### **INVESTIGATION OF RUNWAY EXCURSION ACCIDENT OF TURKISH AIRLINES TC-JOC, A330-303, AT TIA, KATHMANDU, NEPAL ON 4th MARCH 2015**

**Accident investigation commission (TC-JOC, A330-303)  
2015**

**Date: 2015/10/06 (2072/6/19)**

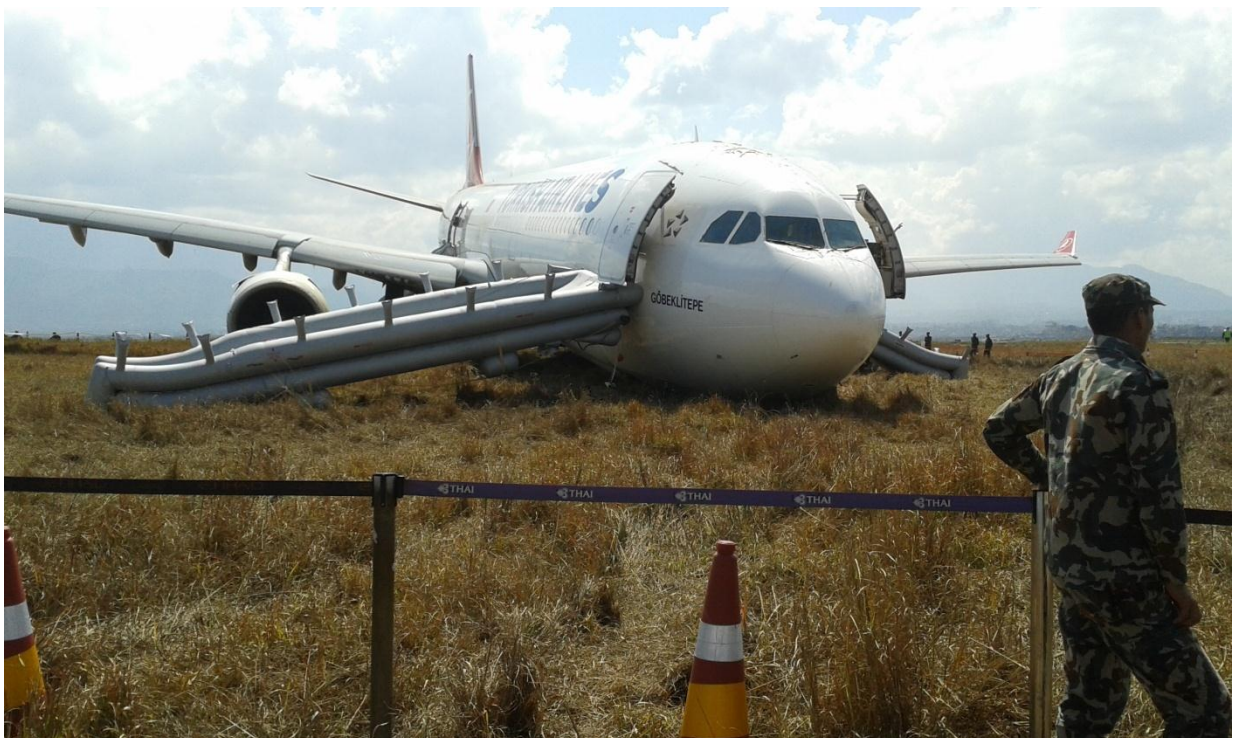
- Nose landing gear was completely collapsed and inserted into the nose well.
- Nose section of fuselage was dragged on the ground and multiple wrinkles were observed on fuselage from nose to angle of attack probe

Nose LG collapsed and inserted inside the wheel well

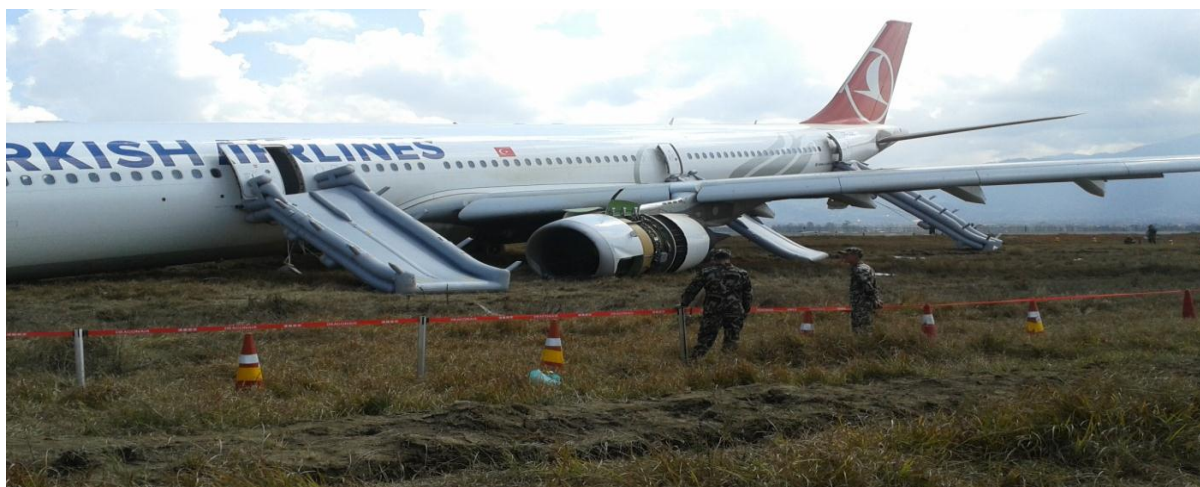
- Belly fairings on both sides of fuselage were damaged.
- Multiple foreign objects damage was seen on the right hand inboard slat.
- Left & right engines had sustained major damage and pylon bended. Thrust reversers were fully deployed, left and right fan cowl were out from engine, inlet cowls were severe damaged, and severe damages were found on fan blades.
- On the left main landing gear all the wheels were broken and out from its hubs, hydraulic fluid leakage observed.
- On the right main landing gear, three wheels were severely damaged and flat, strut door had substantial damage.
- Aircraft was completely out from runway and lying on grass field.
- Significant holes were found on the top of the inboard wing

Left Engine of the Aircraft

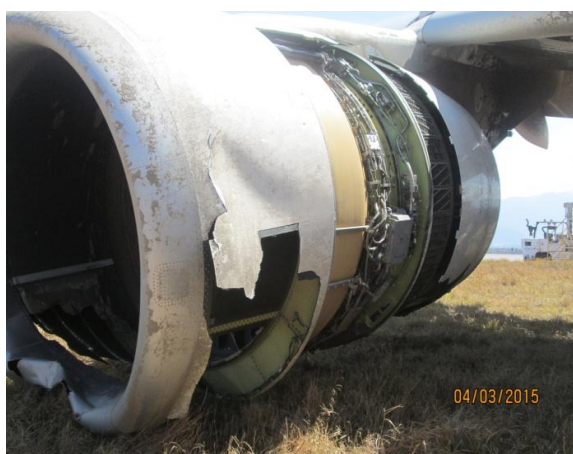
Left Engine Side view

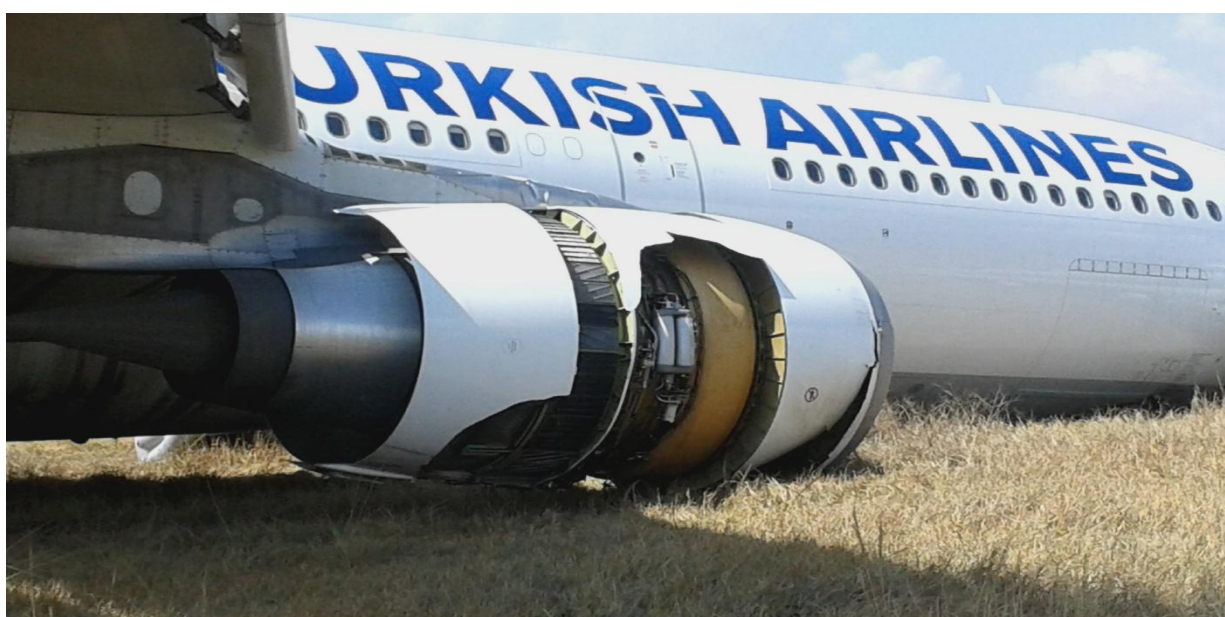
Right Engine

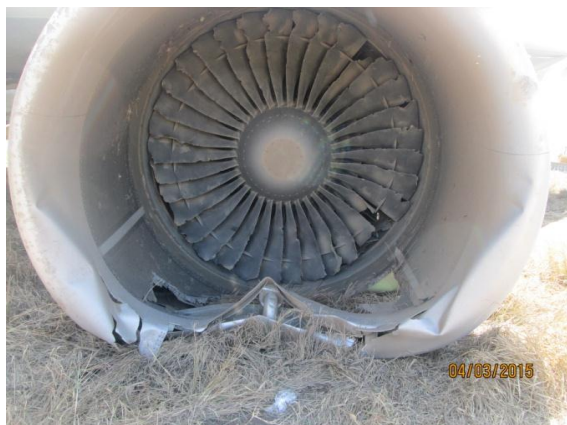
Right Engine

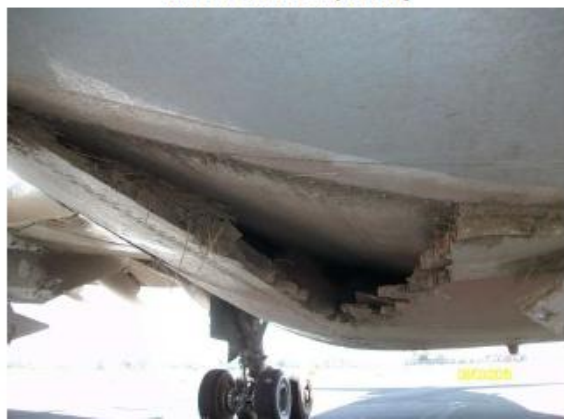
**RH side of the Belly Fairing**

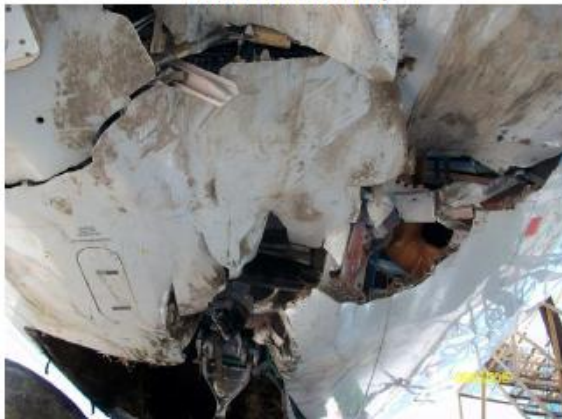
**behind of the NLG bay**

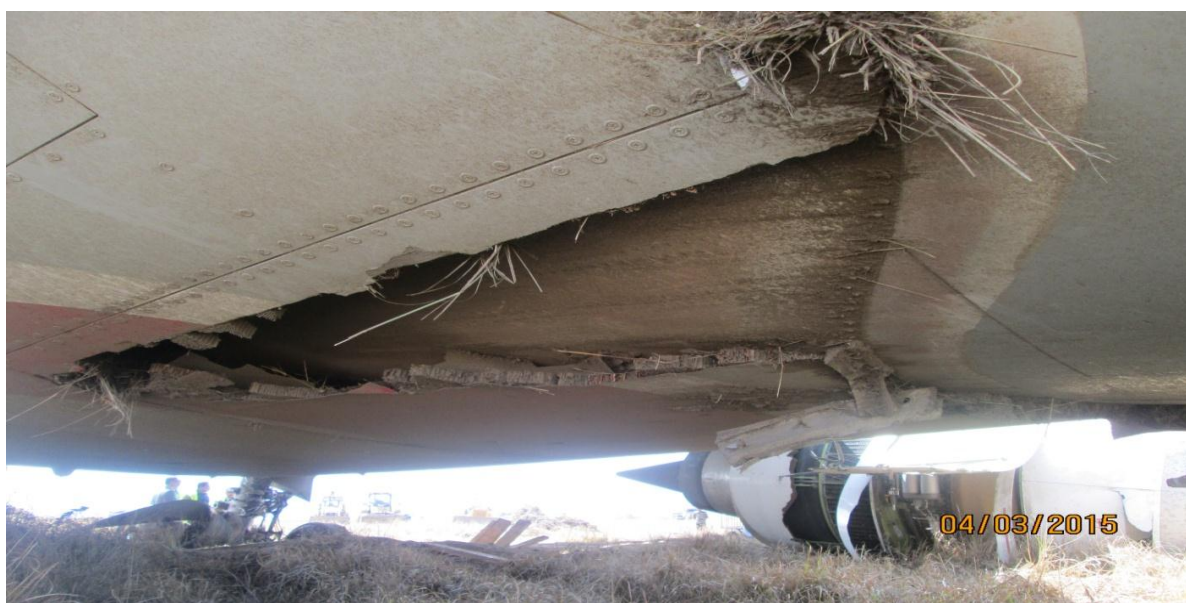
Belly of the aircraft--Fairing

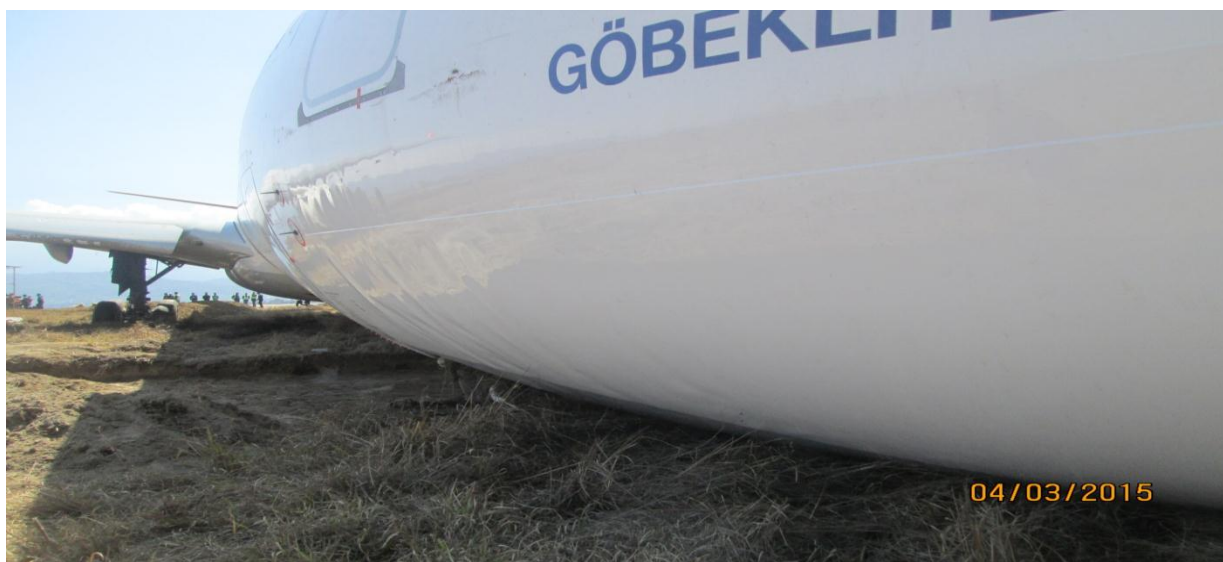
Wrinkles in the Body of the Aircraft

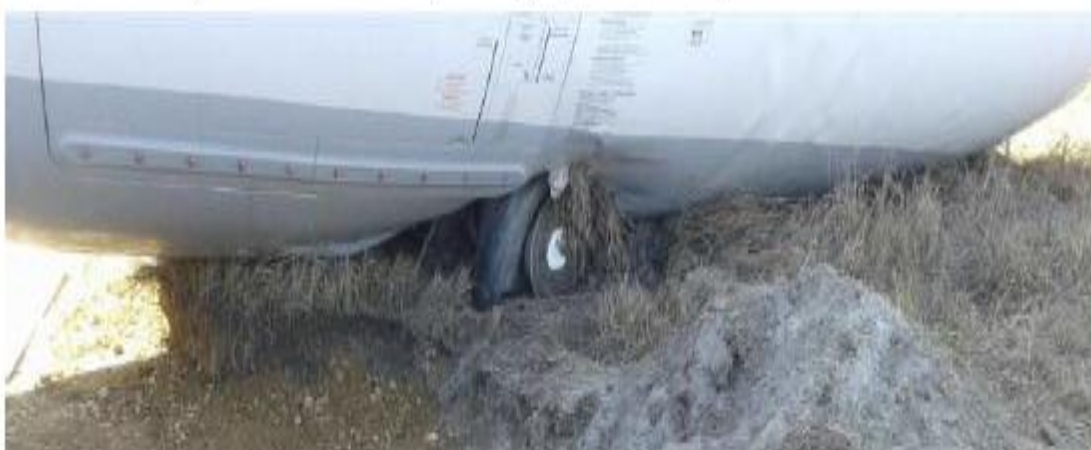
The NLG separated from aircraft (RH hinge pin sheared off):

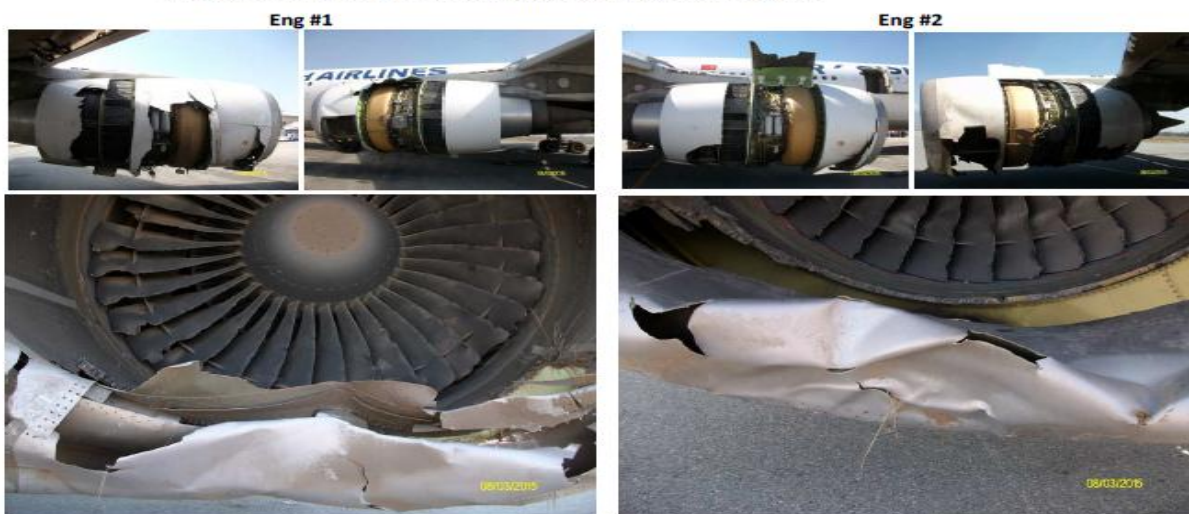
Inlet, fan and reverse cowls were sheared off on both Engines:

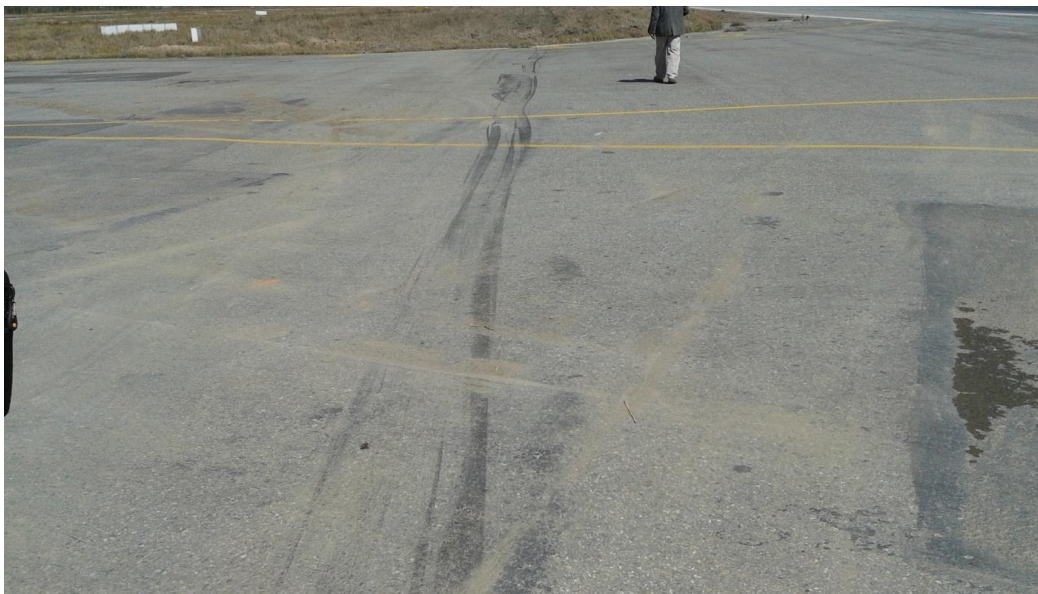
**Right Landing gear Marking on the Runway just before entering into the grass area**

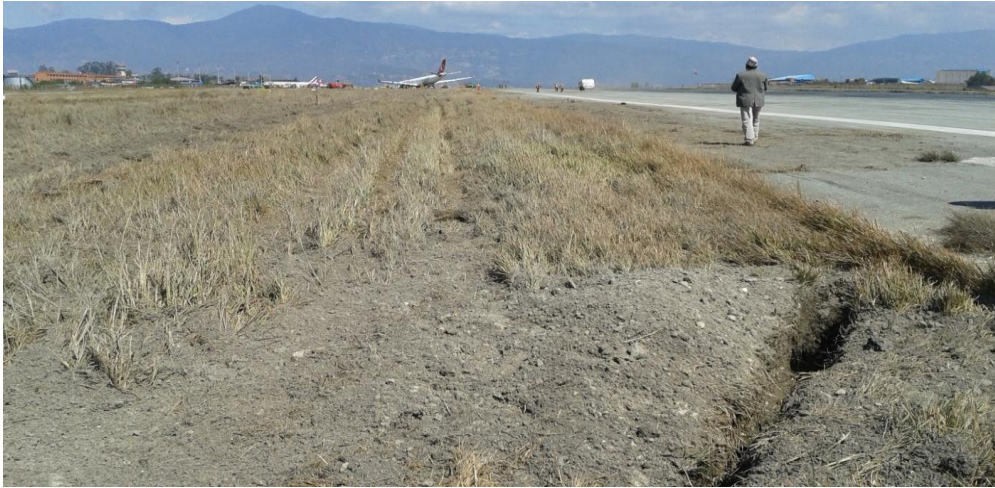
**Both Landing Gears of aircraft rolling outside the runway in Grass area**

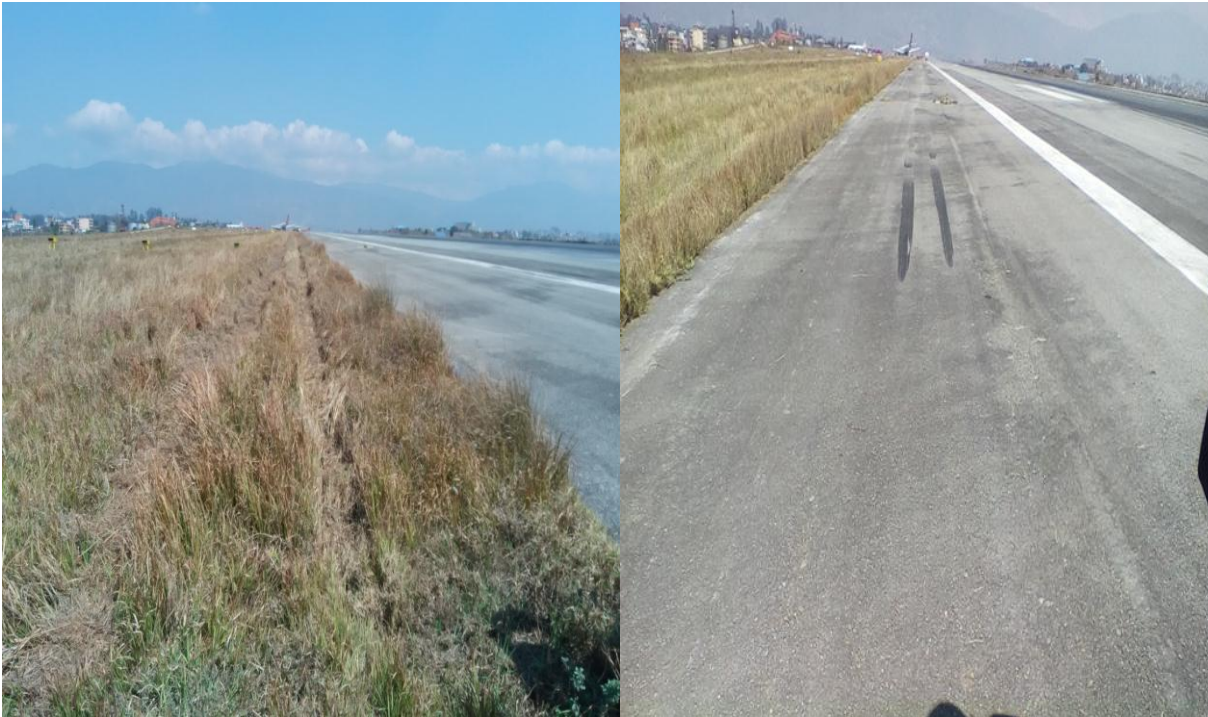
Due to the soft and muddy grass field, the left landing gear dug into the grass field and the aircraft veered toward the left. Initial touchdown mark of wheels and grass field dug by left landing gear is shown below.

**Initial touchdown points of Left and Nose landing Gears**

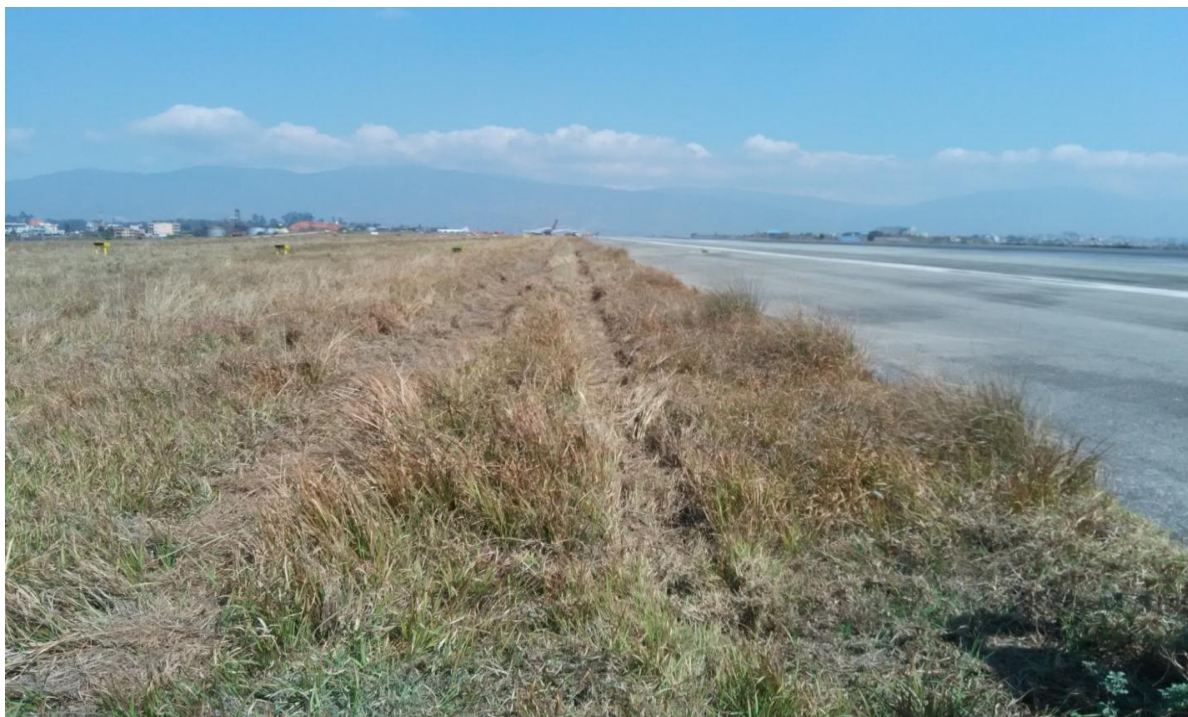
**Initial touchdown point of left landing gear**

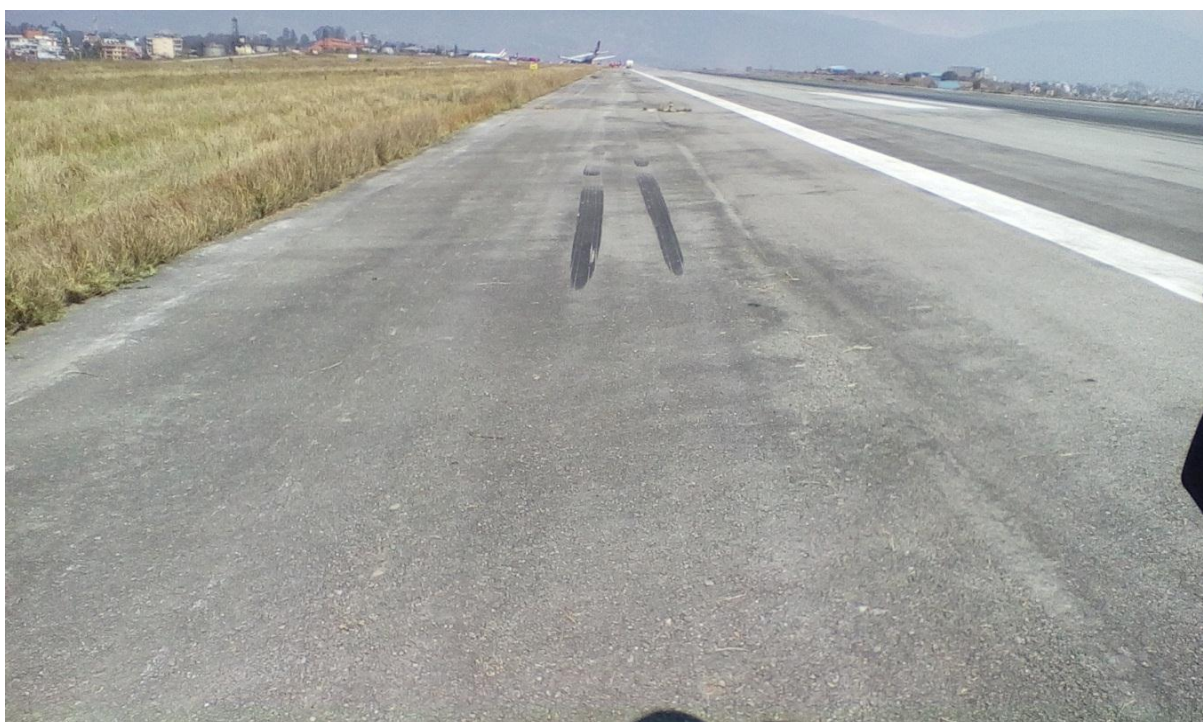
**Initial touchdown point of Nose landing gear.**

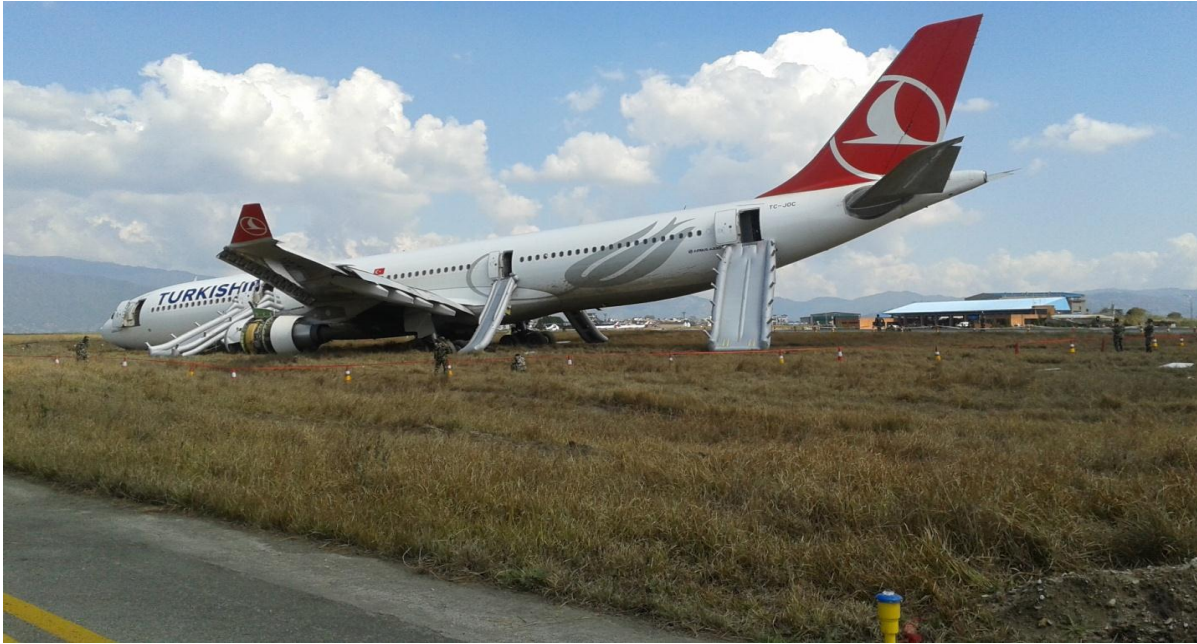
**Aircraft Final position in the Grass area between Taxiway C and D**

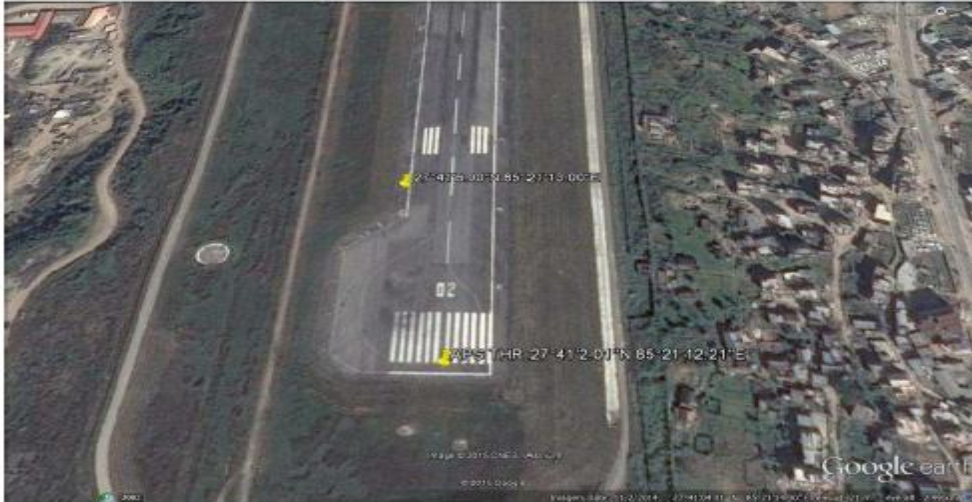
However, it appears that the coordinates of the displaced threshold were not on the runway centreline, but offset from about 26m on the left of the runway centreline. Below plot shows comparison between previous runway threshold coordinates with AIP supplement's based on Google Earth.
