### **INVESTIGATION OF RUNWAY EXCURSION ACCIDENT OF TURKISH AIRLINES TC-JOC, A330-303, AT TIA, KATHMANDU, NEPAL ON 4th MARCH 2015**

**Accident investigation commission (TC-JOC, A330-303)  
2015**

**Date: 2015/10/06 (2072/6/19)**

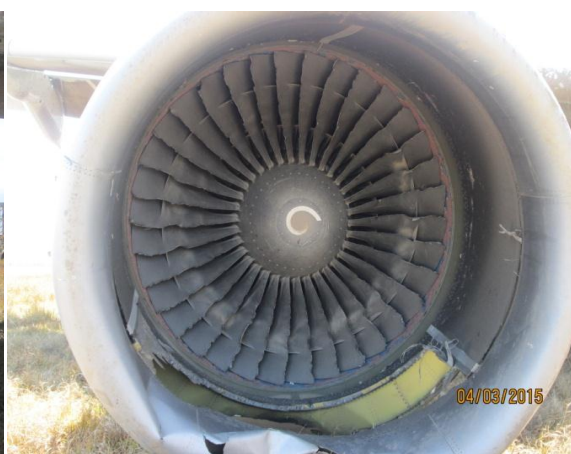
Front View

- Belly fairings on both sides of fuselage were damaged.
- Multiple foreign objects damage was seen on the right hand inboard slat.
- Left & right engines had sustained major damage and pylon bended. Thrust reversers were fully deployed, left and right fan cowl were out from engine, inlet cowls were severe damaged, and severe damages were found on fan blades.
- On the left main landing gear all the wheels were broken and out from its hubs, hydraulic fluid leakage observed.
- On the right main landing gear, three wheels were severely damaged and flat, strut door had substantial damage.
- Aircraft was completely out from runway and lying on grass field.
- Significant holes were found on the top of the inboard wing

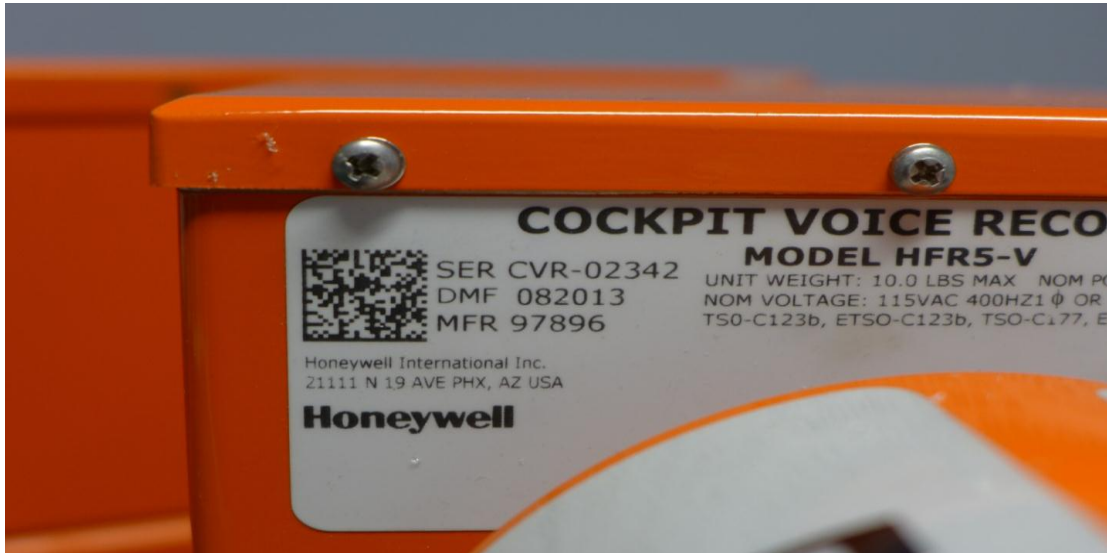
Photo of CVR installed on TC-JOC aircraft

The CVR along with under water locator beacon (ULB) was installed on the aft section of the fuselage. CVR was in normal condition and there was not any sign of damage. The details of installed CVR on TC-JOC (A330-303) aircraft is as follows:

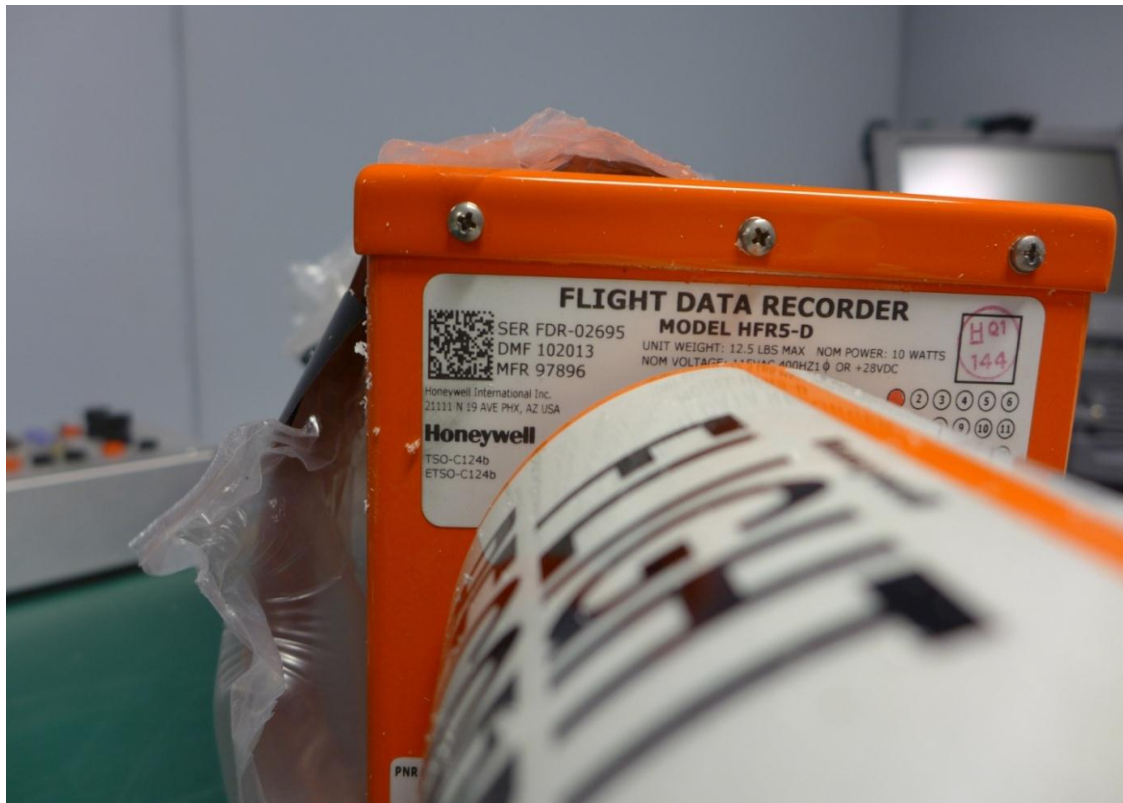
**Photo of FDR in stalled on TC-JOC aircraft**

- 1.13.2.2 The FDR was installed on the aft section of the fuselage. The ULB was also attached to the FDR. The last 25 hours data was stored in the FDR. When the FDR was removed, it was in good condition and there was no any sign of damage and fire.
